# ***Overview of the Accident in Fukushima Daiichi Nuclear Power Plant***

***Prof. Naoto Sekimura, Ph.D***

***Vice Dean, School of Engineering  
Department of Nuclear Engineering and Management  
The University of Tokyo***

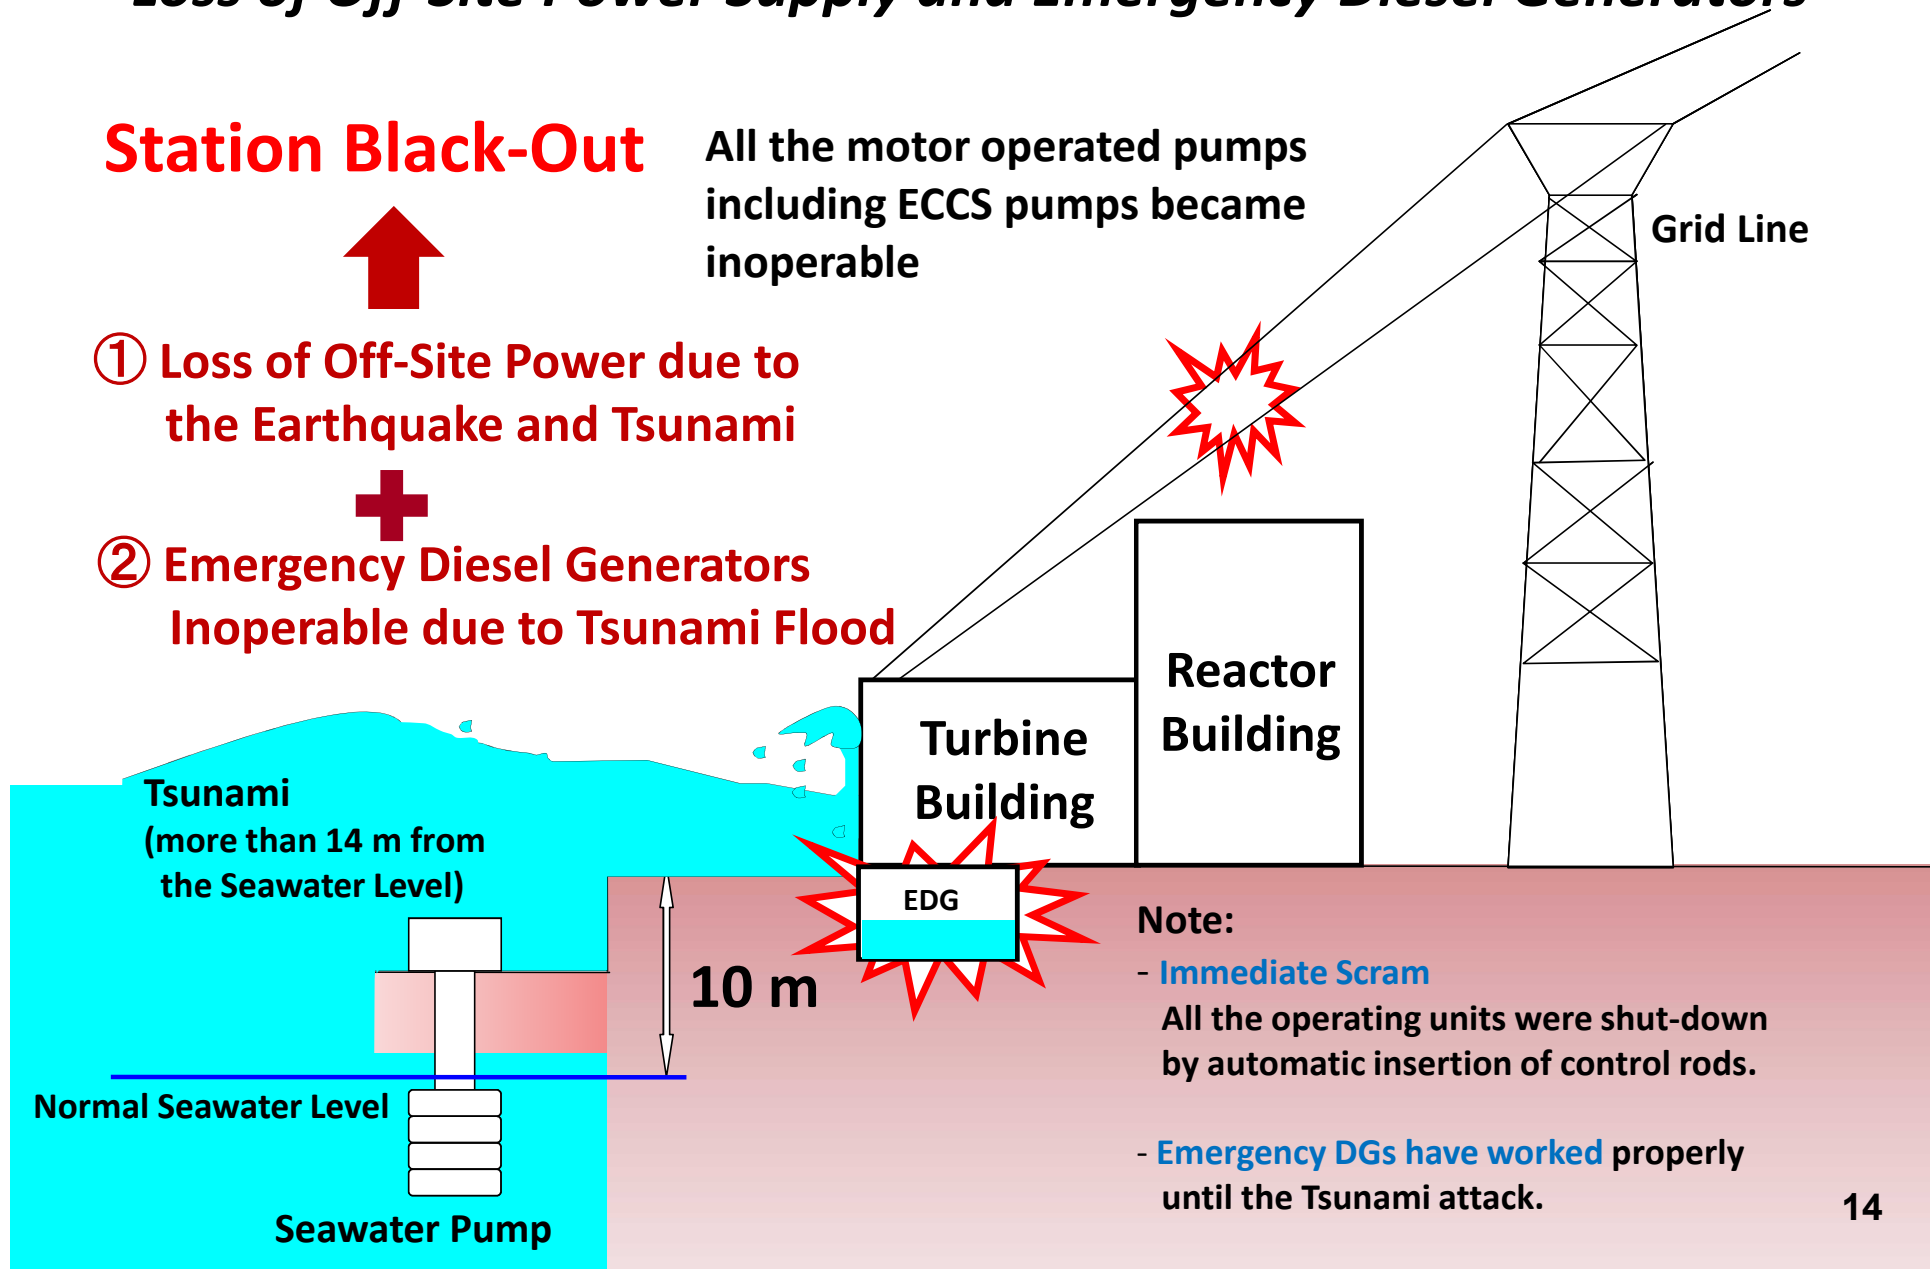
### Station Black-Out

All the motor operated pumps including ECCS pumps became inoperable

① Loss of Off-Site Power due to the Earthquake and Tsunami

② Emergency Diesel Generators Inoperable due to Tsunami Flood

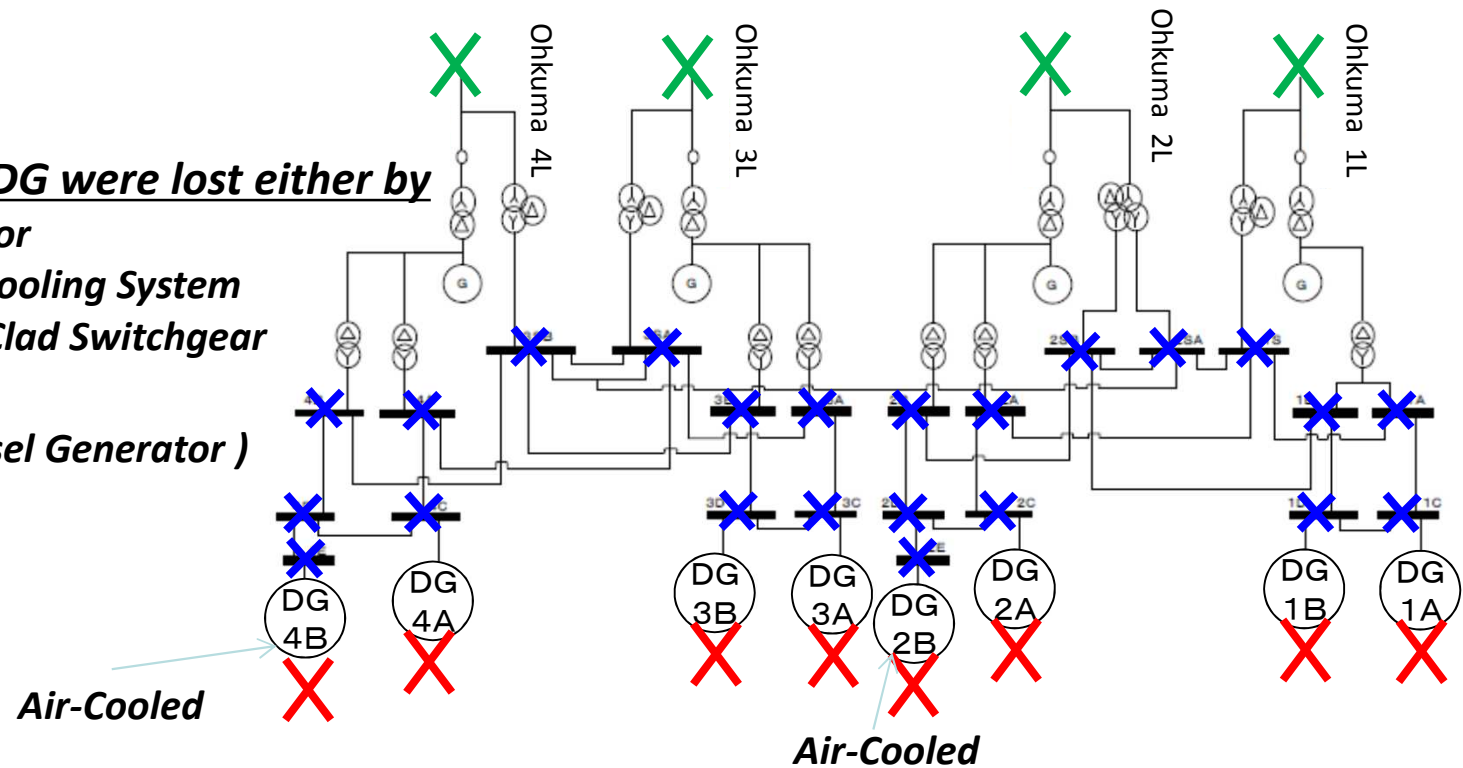
Okuma 1L,2L : Breakers were broken due to the earthquake

Okuma 3L : Under modification

### Functions of all the EDG were lost either by

- 1) *Damage in Generator*
- 2) *Loss of Sea-Water Cooling System*
- 3) *Damage at Metal-Clad Switchgear*

Unit 2 on March 20, Unit 1,3,4 on March 22

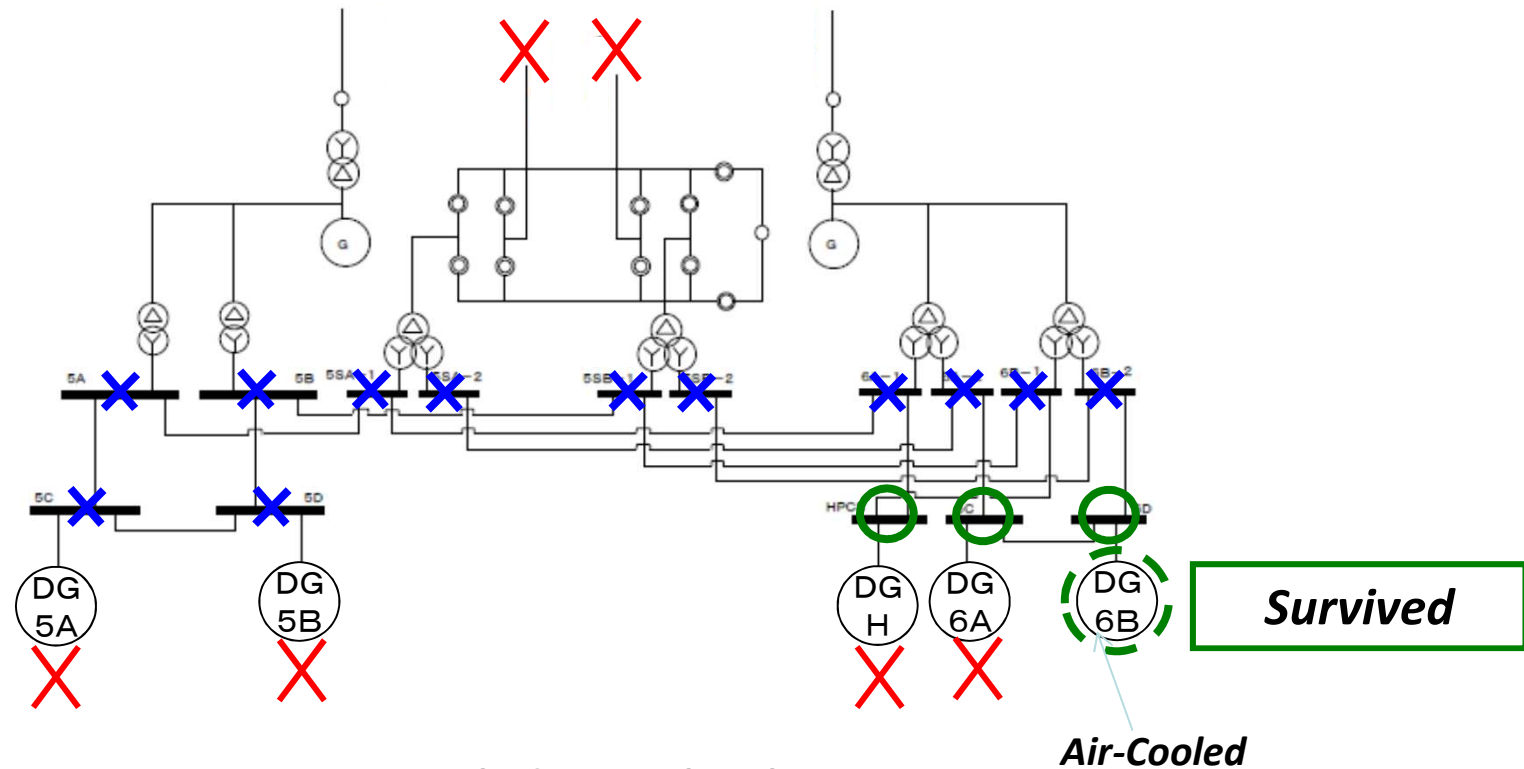
*Pylons damage by the earthquake caused loss of off-site power supply*

*Damage in sea-water cooled EDGs by the tsunami*

*\* Recovery of Off-site Power Supply on March 20-21*

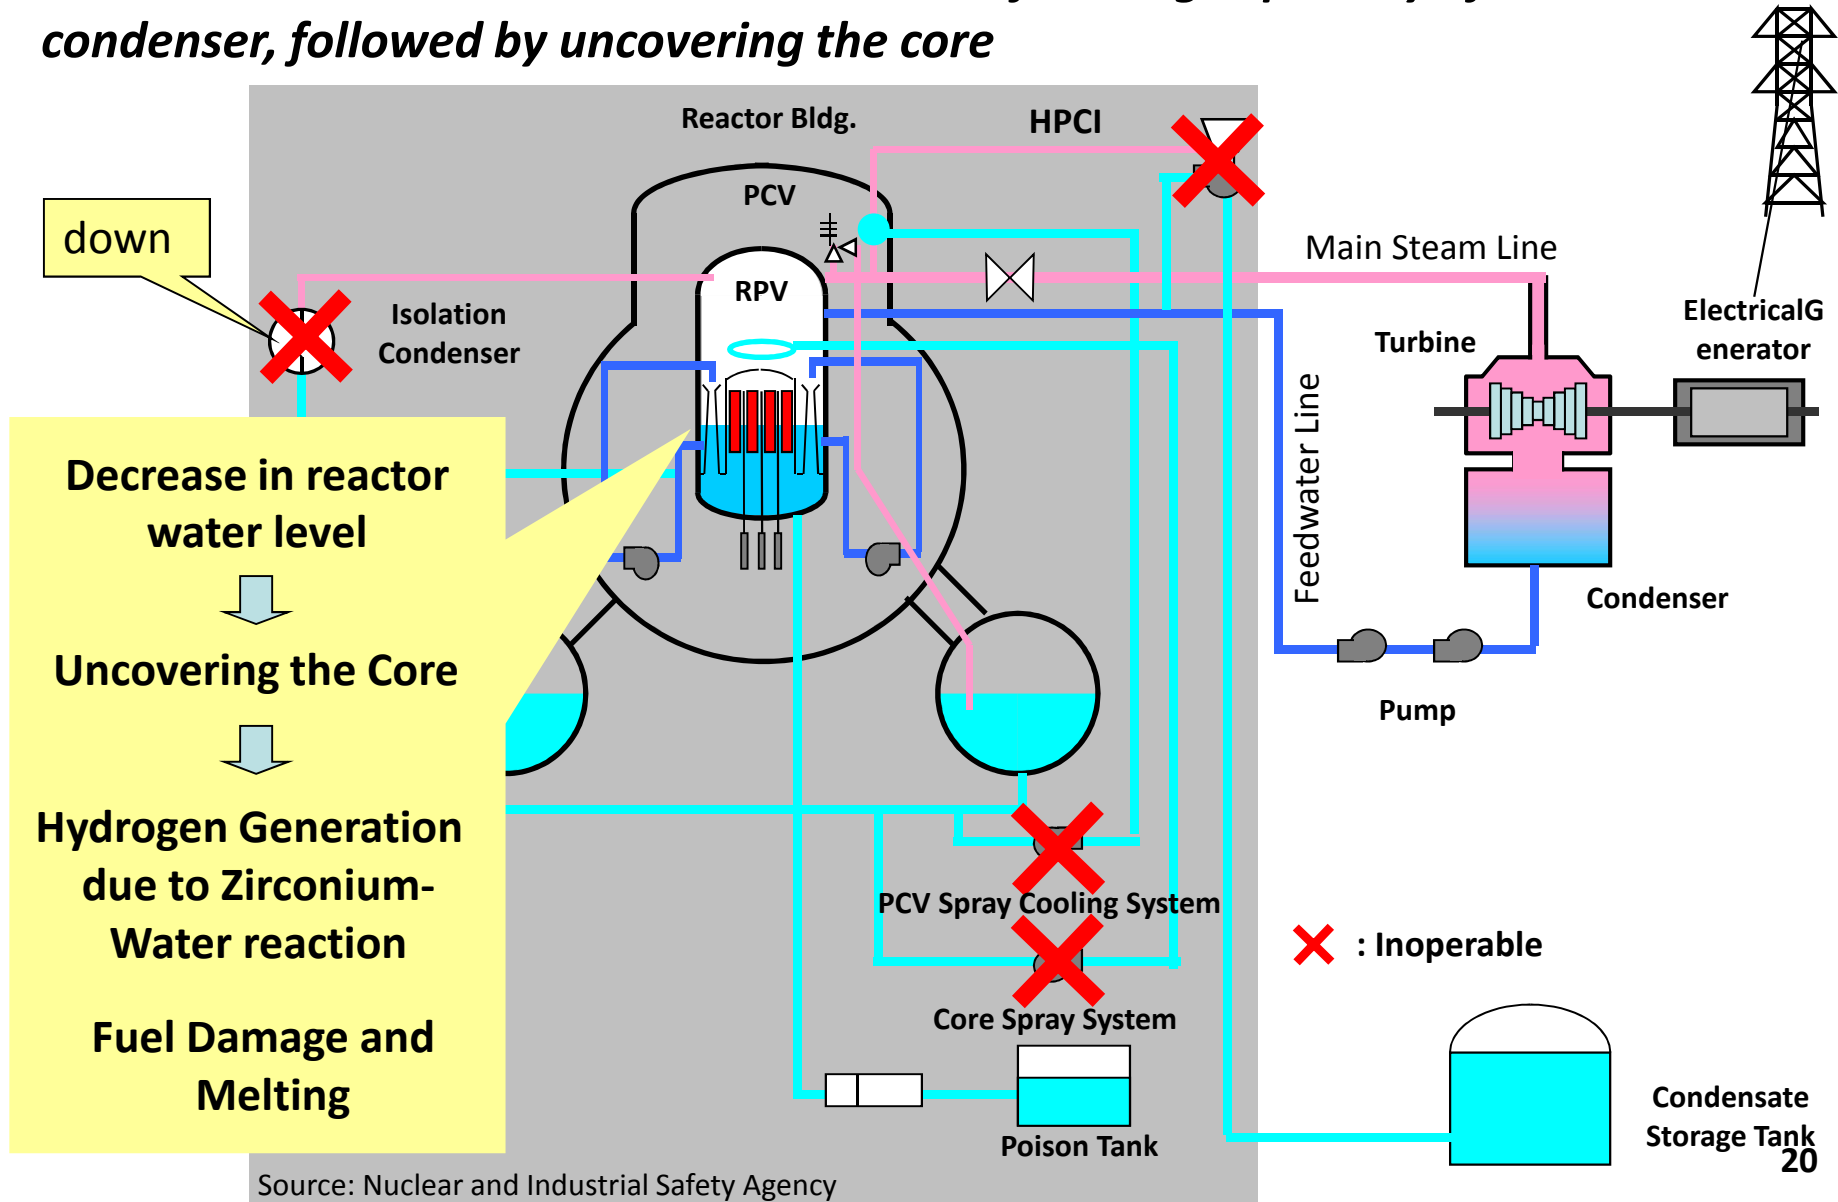
# Unit 1 : Loss of Cooling

*Decrease in reactor water level due to loss of cooling capability of Isolation condenser, followed by uncovering the core*

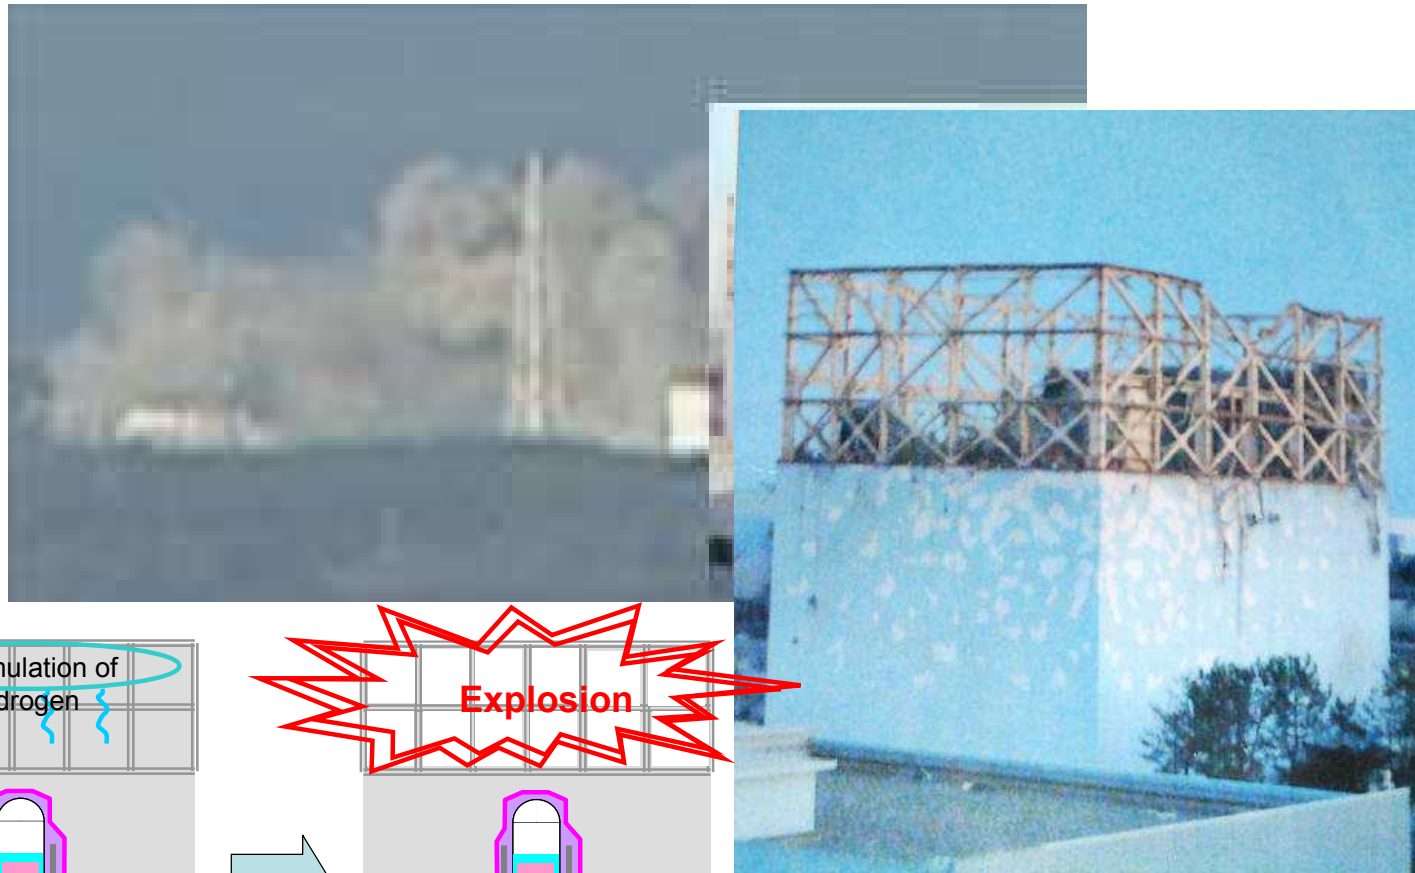
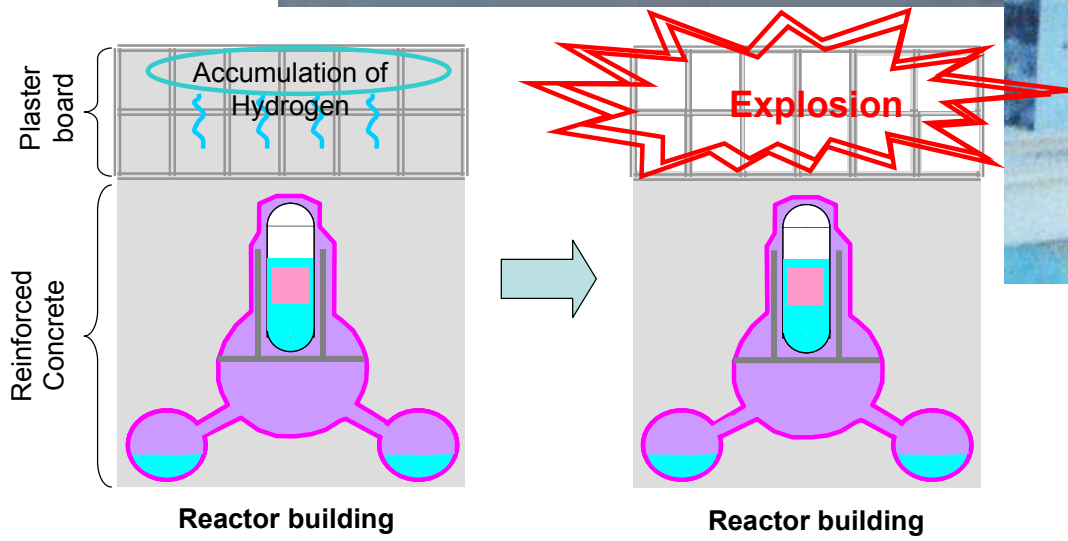
# *Hydrogen Explosion in the Operation Floor in Unit 1*

*- March 12, 15:36 -*

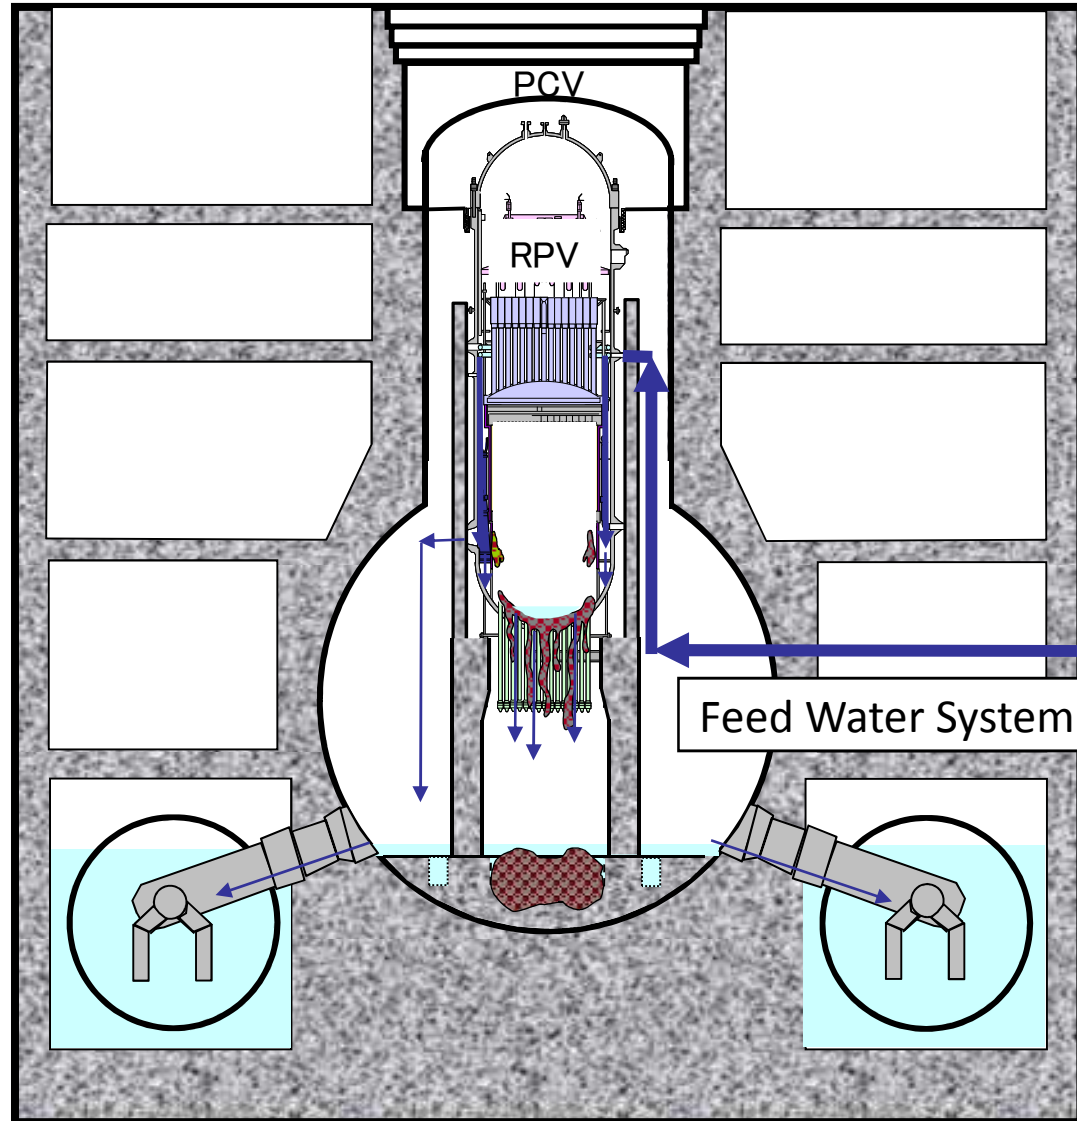
# Summary of Damage in Unit 1

- MAAP code analysis indicates;  
**All fuel rods were melted and relocated to the RPV bottom.**  
**A considerable quantity of fuel dropped to the PCV bottom.**

- Currently water is injected to the RPV via the feed water piping. Temperature of the RPV bottom and the PCV is stable at less than 100 C .
- **Almost all fuel dropped to the PCV bottom, is in contact with water, and is cooled.**

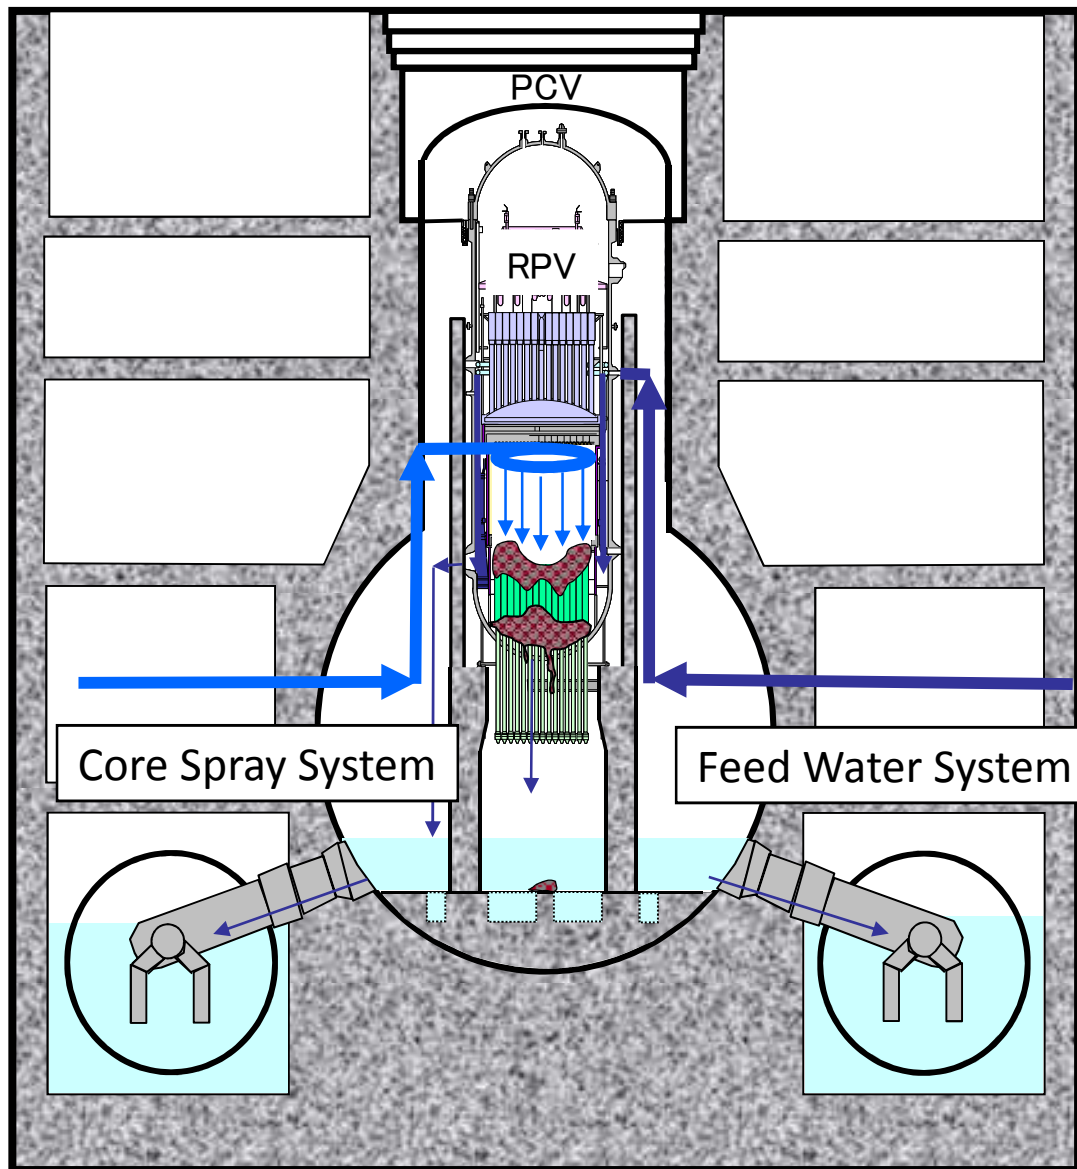
## Summary in Units 2 and 3

- Although fuel was damaged and melted, some fuel remains at the core. And some fuel dropped to the RPV plenum or to the pedestal in the PCV.

- Currently water is injected to the RPV via the feed water piping and core spray piping. Temperature at the each part of the PCV is stable at 100°C or less. Therefore, the fuel at each location is in contact with water, and is cooled.

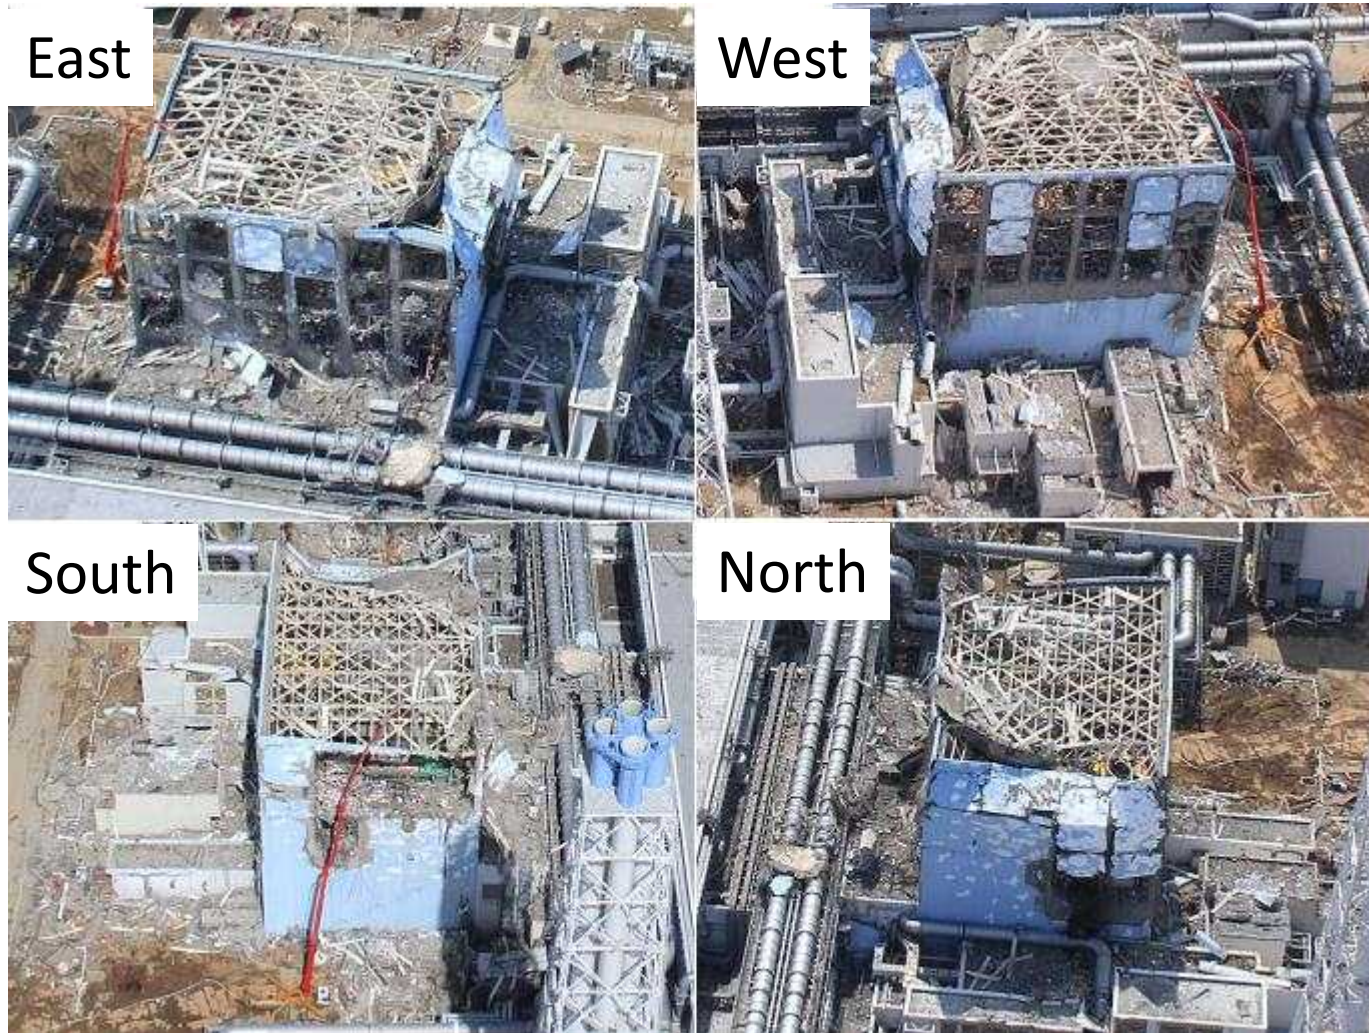
# *Hydrogen Explosion in Unit 4 on March 15*

Possible mechanisms ; (1) Zr-H<sub>2</sub>O reaction in the SFP, (2) H<sub>2</sub> from Unit 3,  
(3) Decomposition of H<sub>2</sub>O into H<sub>2</sub> and O<sub>2</sub> under radiation

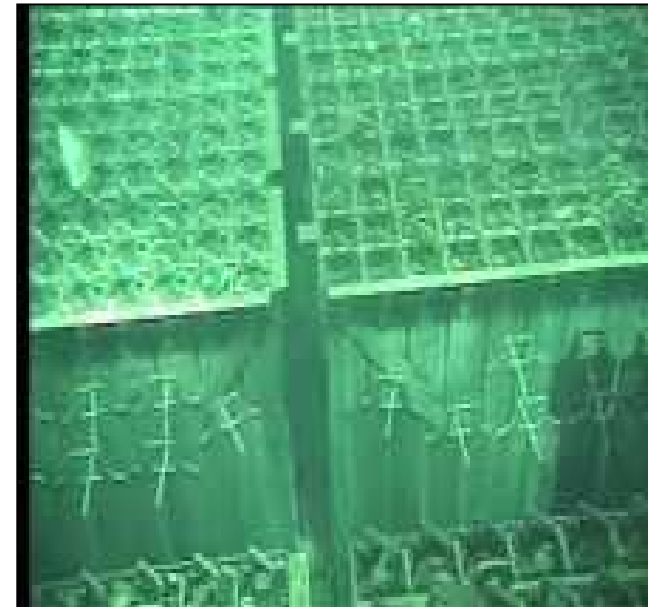
## Unit 4 : Spent Fuel Pool

- ◆ *No significant damage was identified by underwater camera inspection*
- ◆ *Water sampling also shows relatively low radioactivity in SFP water*

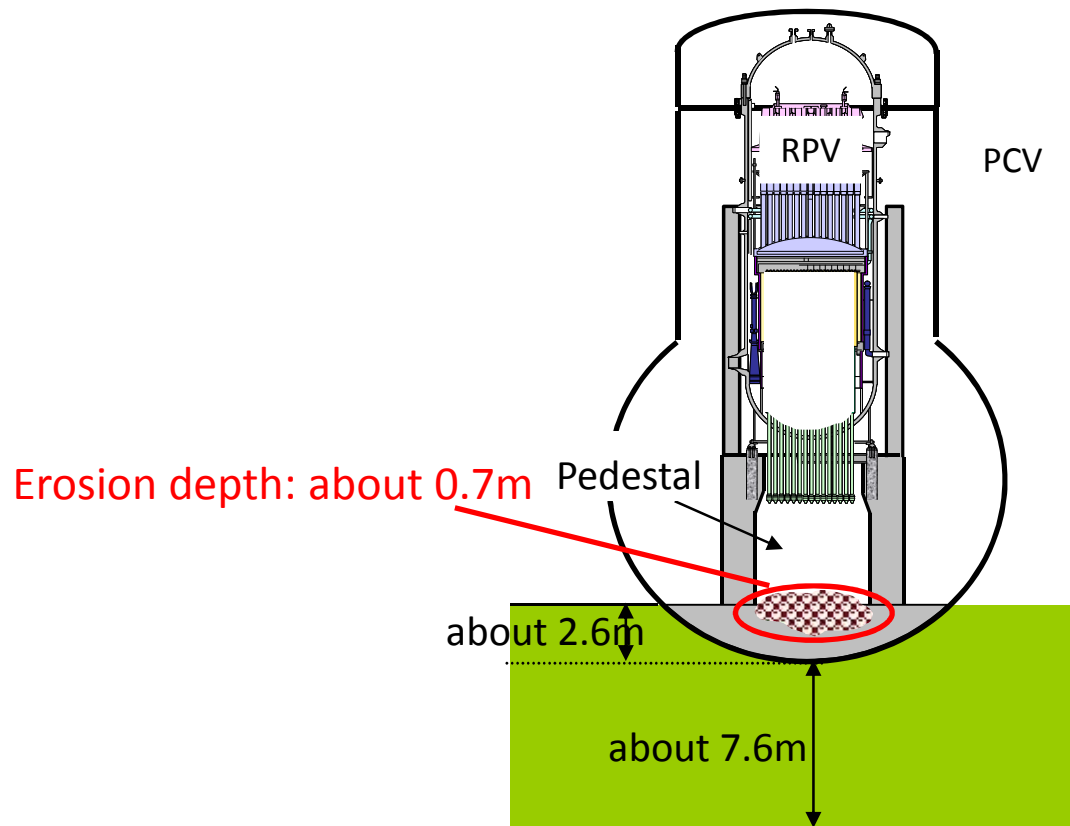
# Erosion of Concrete in RCV in Unit 1

- Possibly the melted fuel eroded concrete at the PCV bottom. The erosion depth analysis was carried out by MAAP code. **On realistic conditions, the result of the erosion depth analysis became about 0.7m.**
- **The gas emitted by the disassembly of concrete is not detected, indicating no further erosion of concrete by the melted fuel.**
