# ***Overview of the Accident in Fukushima Daiichi Nuclear Power Plant***

***Prof. Naoto Sekimura, Ph.D***

***Vice Dean, School of Engineering  
Department of Nuclear Engineering and Management  
The University of Tokyo***

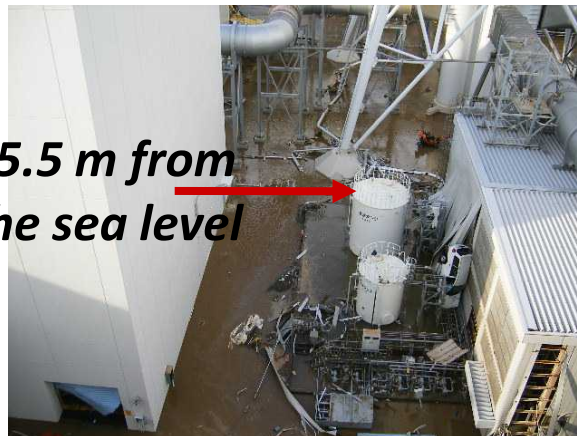
15.5 m from  
the sea level →

**Inundation height of the Tsunami in Fukushima Daiichi was about 15 m.**

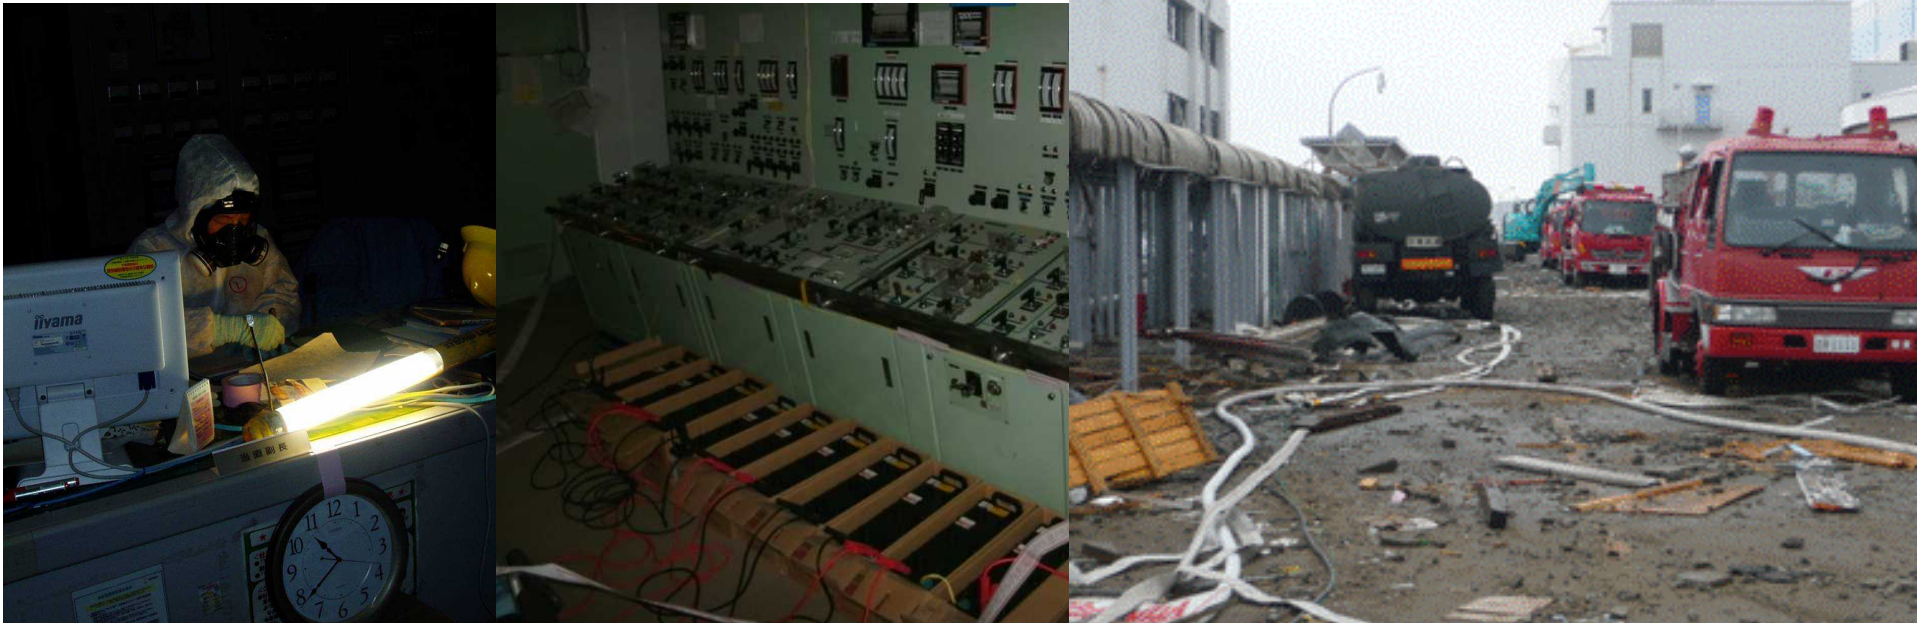
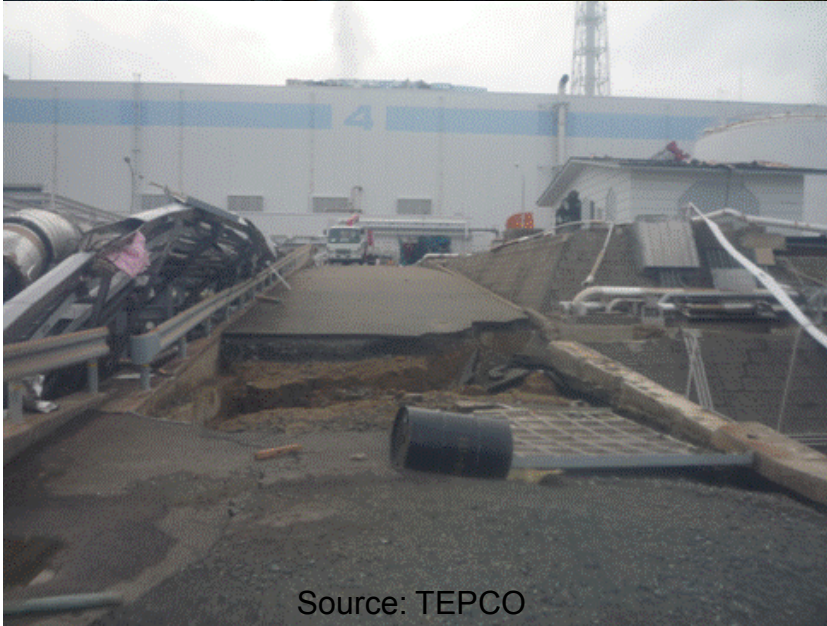
- **After the Tsunami,**
  - **No lighting available**
  - **What they can get are flashlights, batteries (some are removed from automobiles), fire trucks and some compressors**
  - **Very difficult to measure the major safety parameters like water level, reactor pressure, CV pressure**

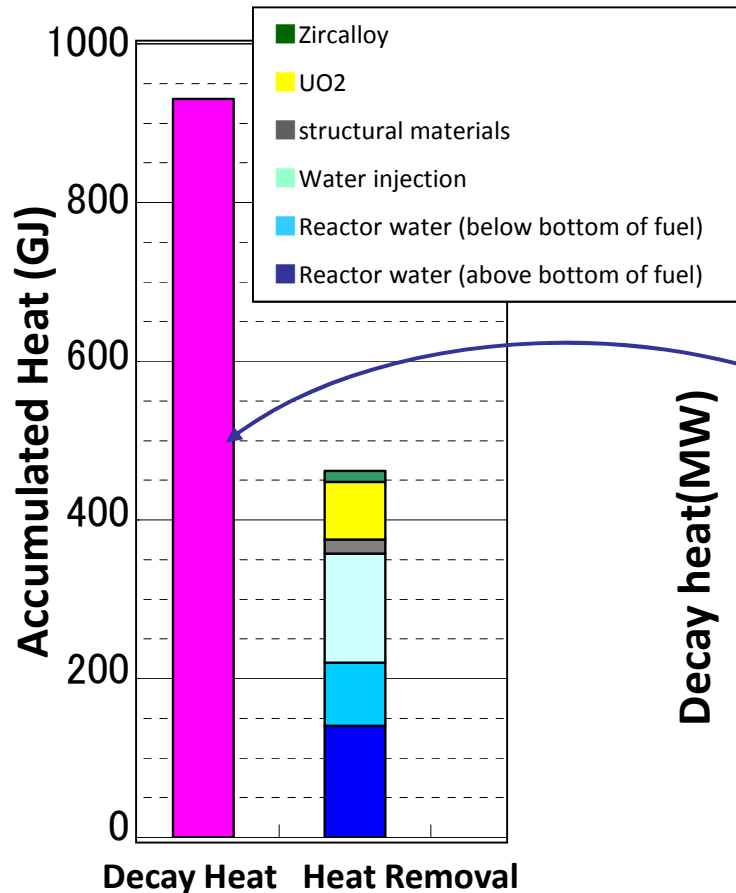
*Decay Heat* » *Heat Removal*

- Total decay heat before sea water injection greatly exceeds the amount of heat which reactor water and structural materials could absorb.
- All molten core moved to RPV bottom and they damaged RPV and run down to PCV.

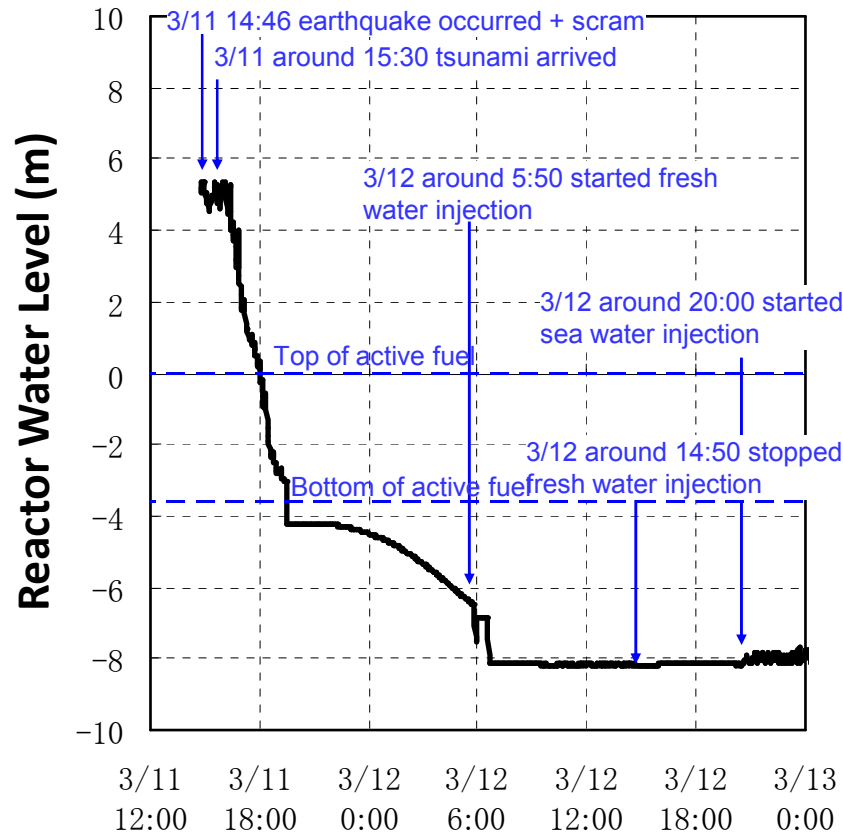
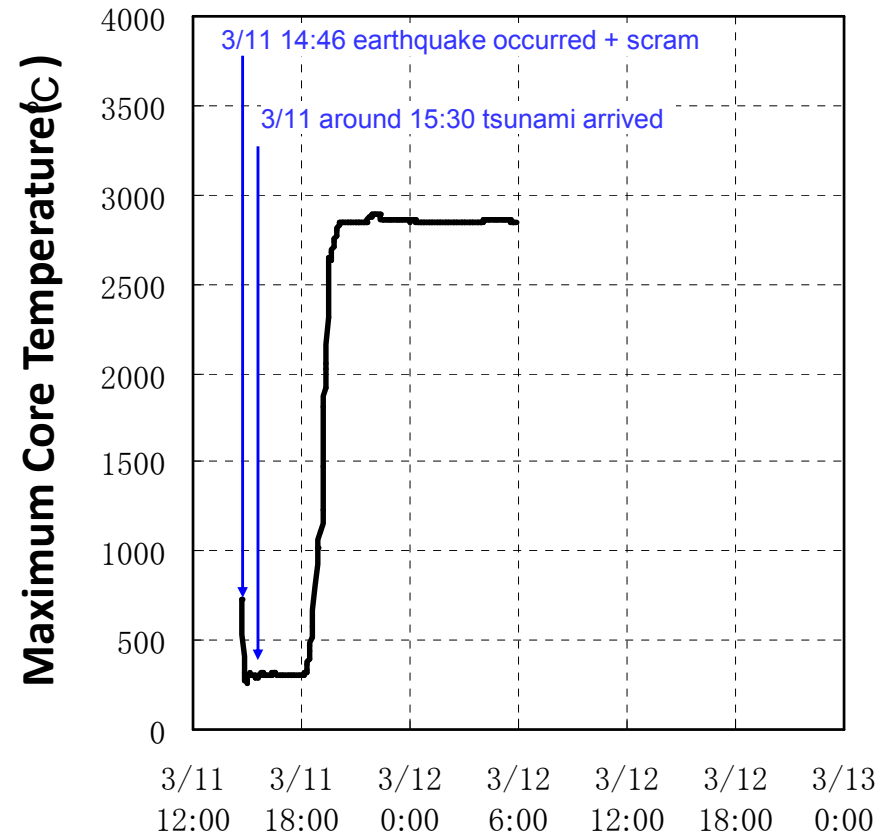
Assuming that IC lost its function by the Tsunami

- reached top of active fuel in 3 hours (around 18:00) after the scram
- reached bottom of active fuel in 4 and a half hours (around 19:30) after the scram

The core temperature started increasing when the reactor water level became lower than top of active fuel, then reached the core melting temperature.

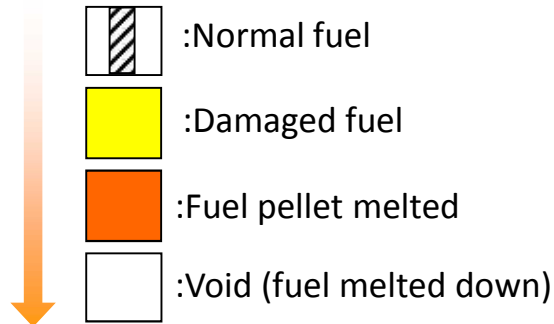
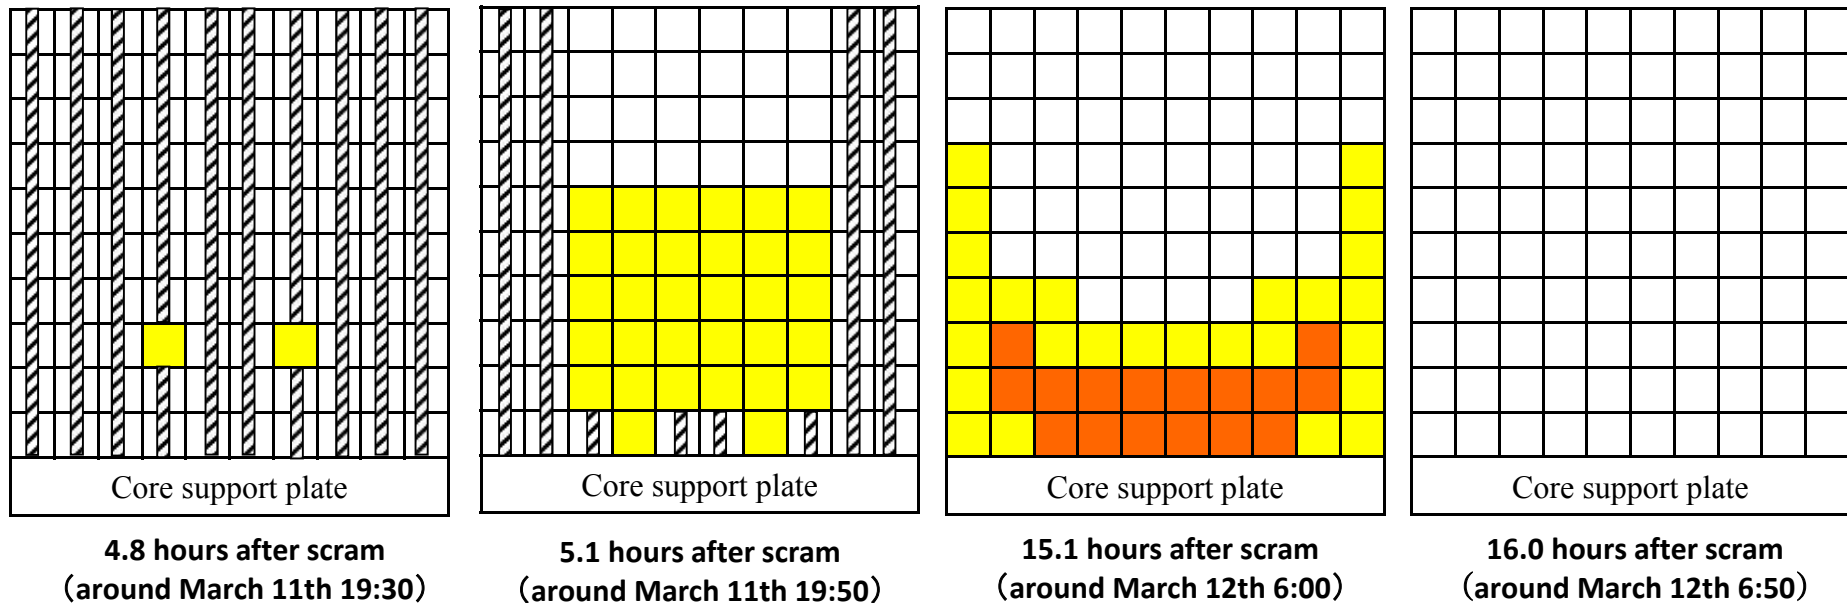
- Melting starts from the central part of the core.
- In 16 hours after scram, most part of the core fell down to the RPV bottom.
- Although RPV is damaged in this provisional analysis, the actual damage of RPV is considered to be limited according to the temperatures presently measured around the RPV.

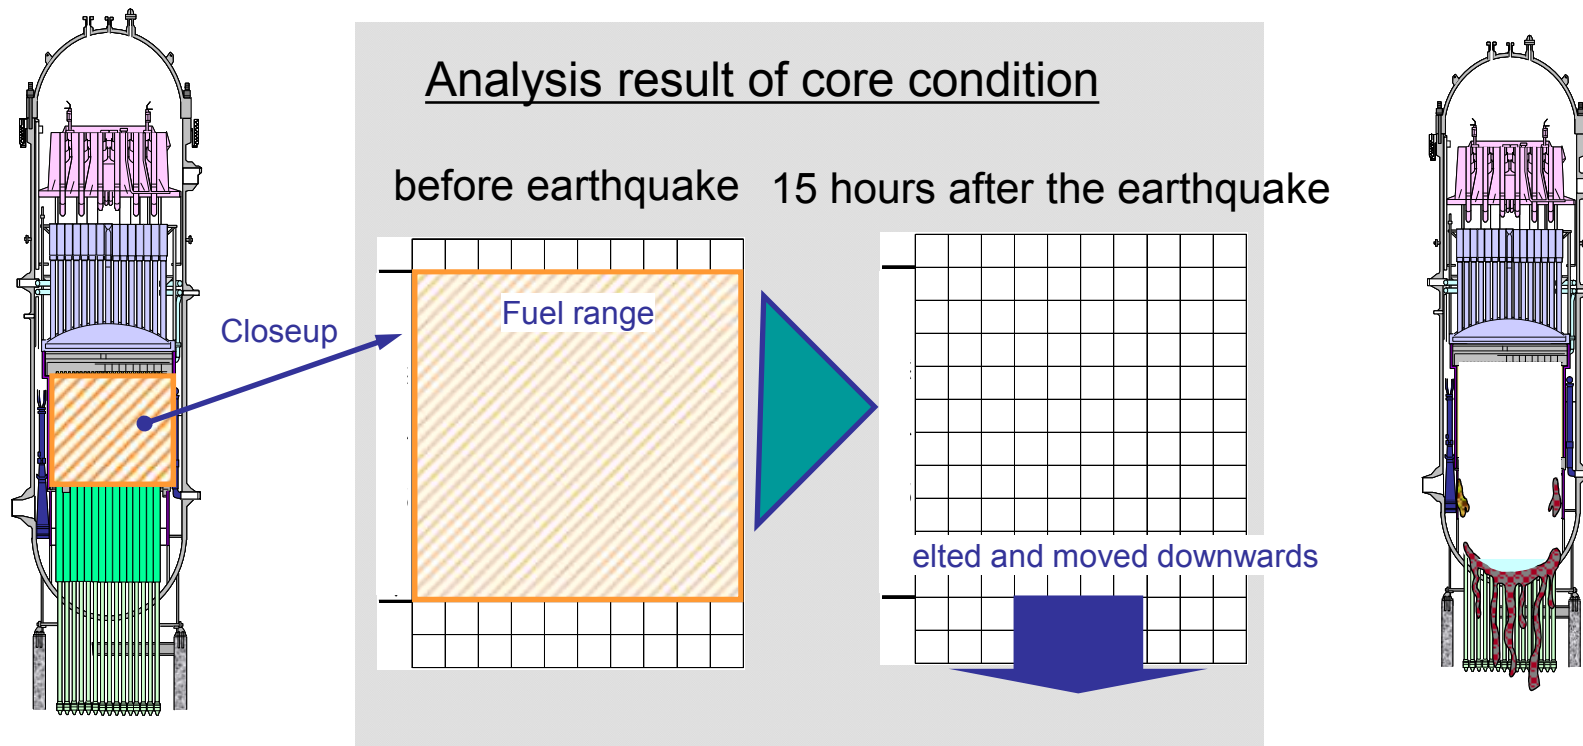
- All the fuels were melted and moved downwards from fuel range.
- RPV is likely to be damaged by molten core.

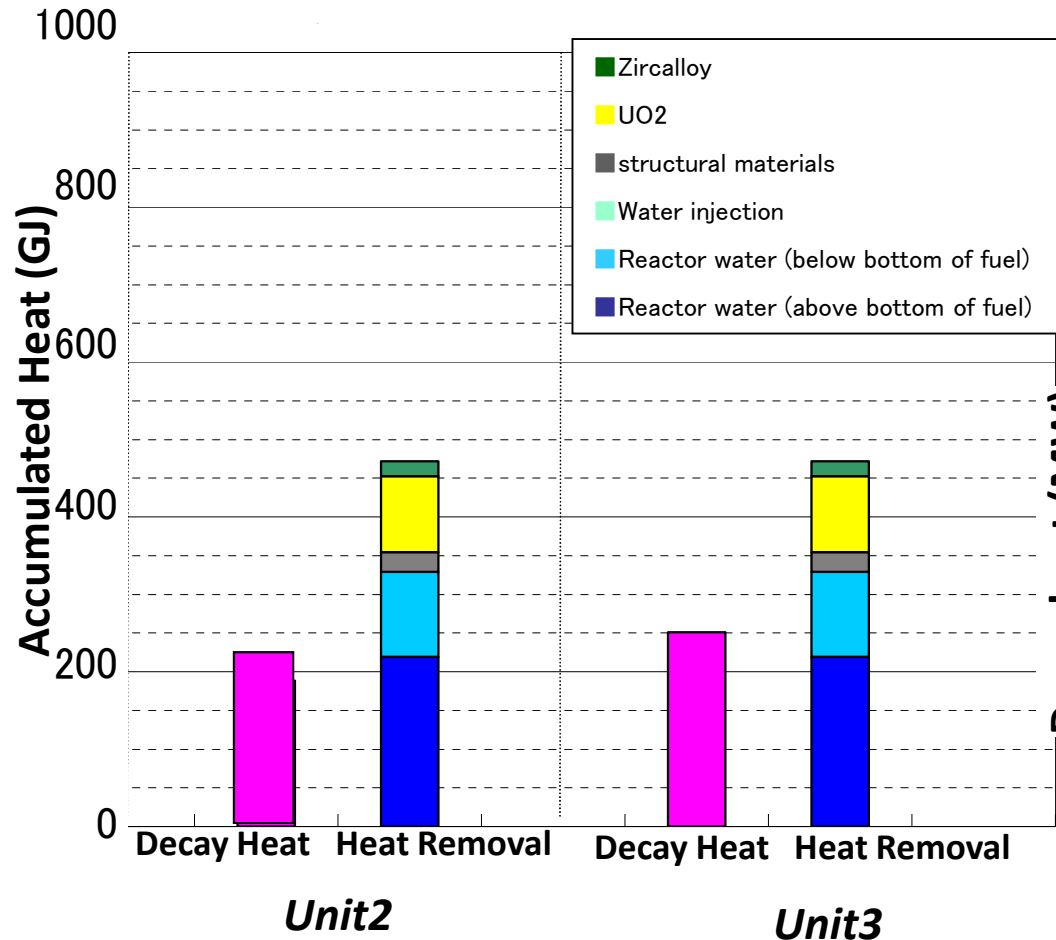
# Balance between Decay Heat and Heat Removal in Units 2 & 3

- Decay heat generated in the period where water injection was interrupted exceeded the heat removal amount which reactor water and structural materials could absorb.
- It is assumed that certain amount of fuel possibly melted and moved downwards, which also lead damage RPV.

In units 2 & 3, the period where water injection was interrupted was shorter than unit1

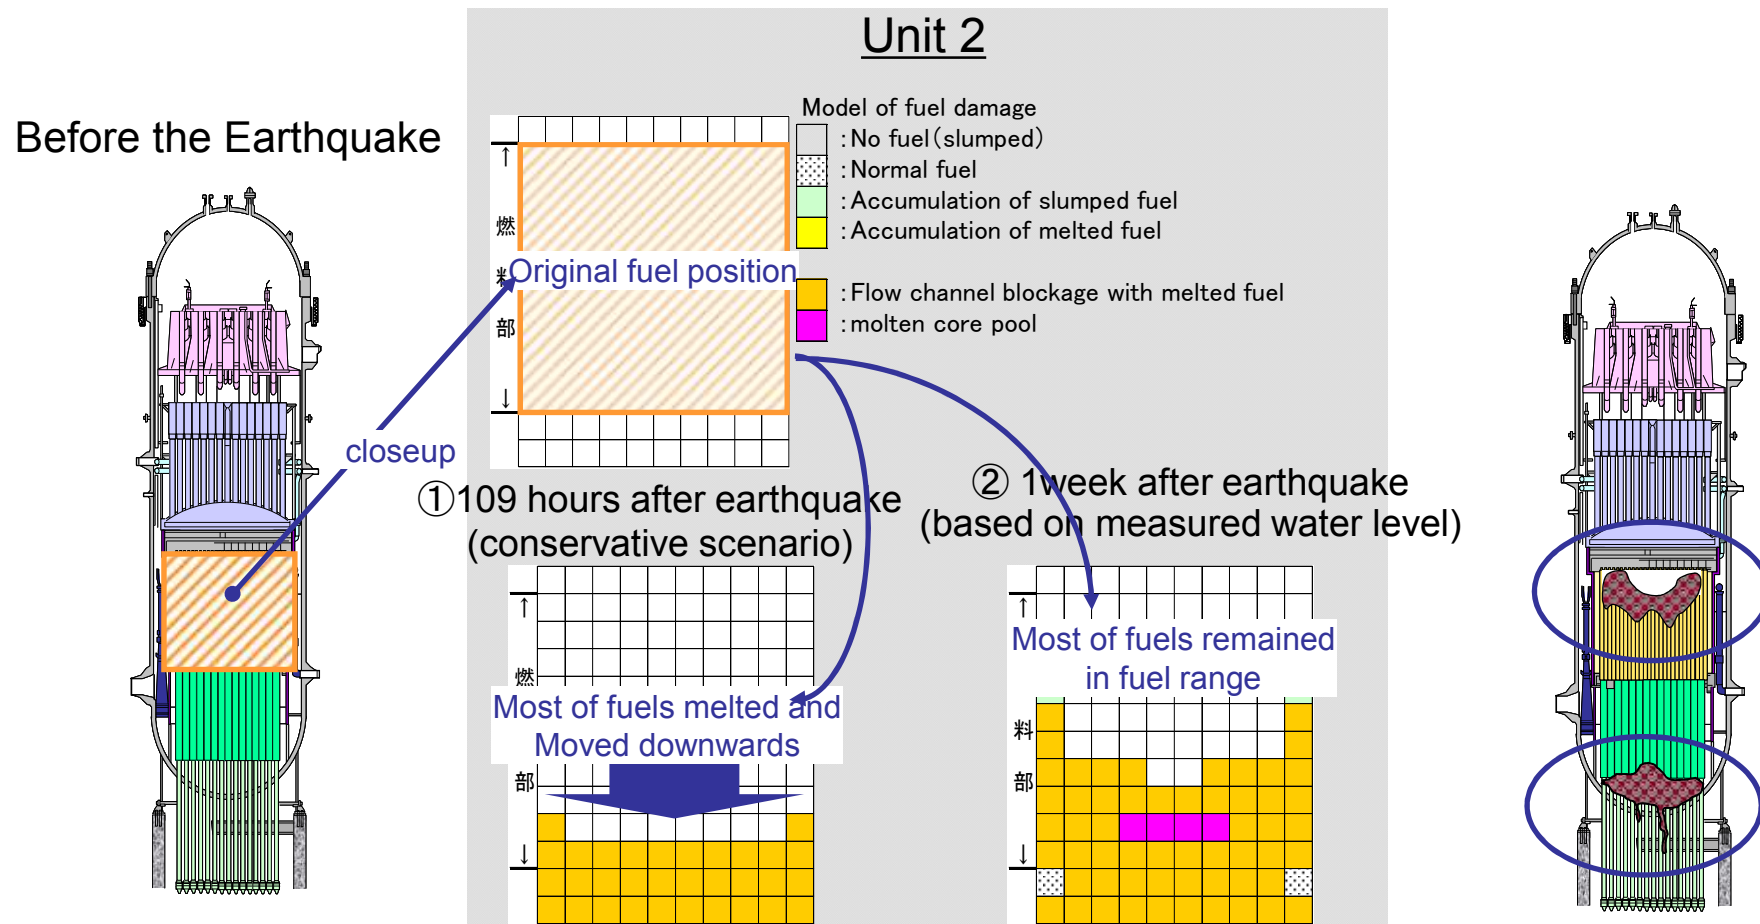
# Summary of Simulation Results by the MAAP code in Units 2 and 3

- Most of fuels melted and moved to RPV bottom in the conservative scenario which assume smaller amount of water injection considering uncertainty of reactor water level indicator.
- Although some fuels were damaged, most of fuels remained in fuel range in the scenario based on measured water level with indicator.

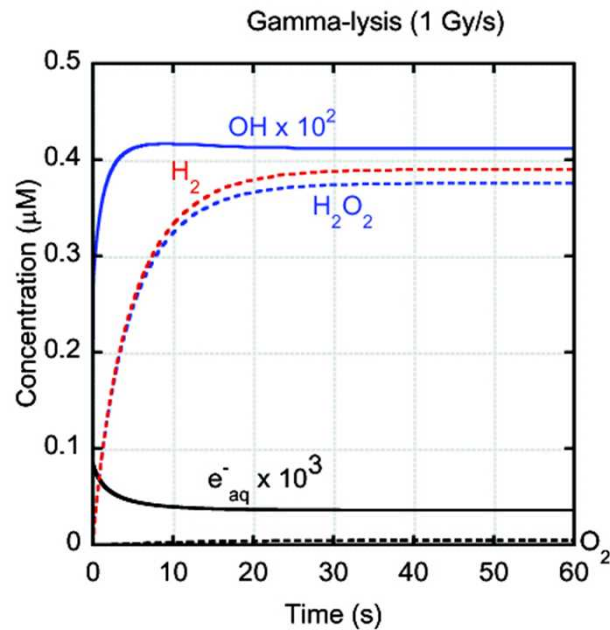
Typical BWR condition simulation of radiation chemistry reactions considering the reaction between H<sub>2</sub> and OH, resulting in steady state concentration of H<sub>2</sub>.

- Effective transfer of H<sub>2</sub> into gas phase at 100 C
- High concentration of H<sub>2</sub> through condensation of H<sub>2</sub>O at lower temperature region

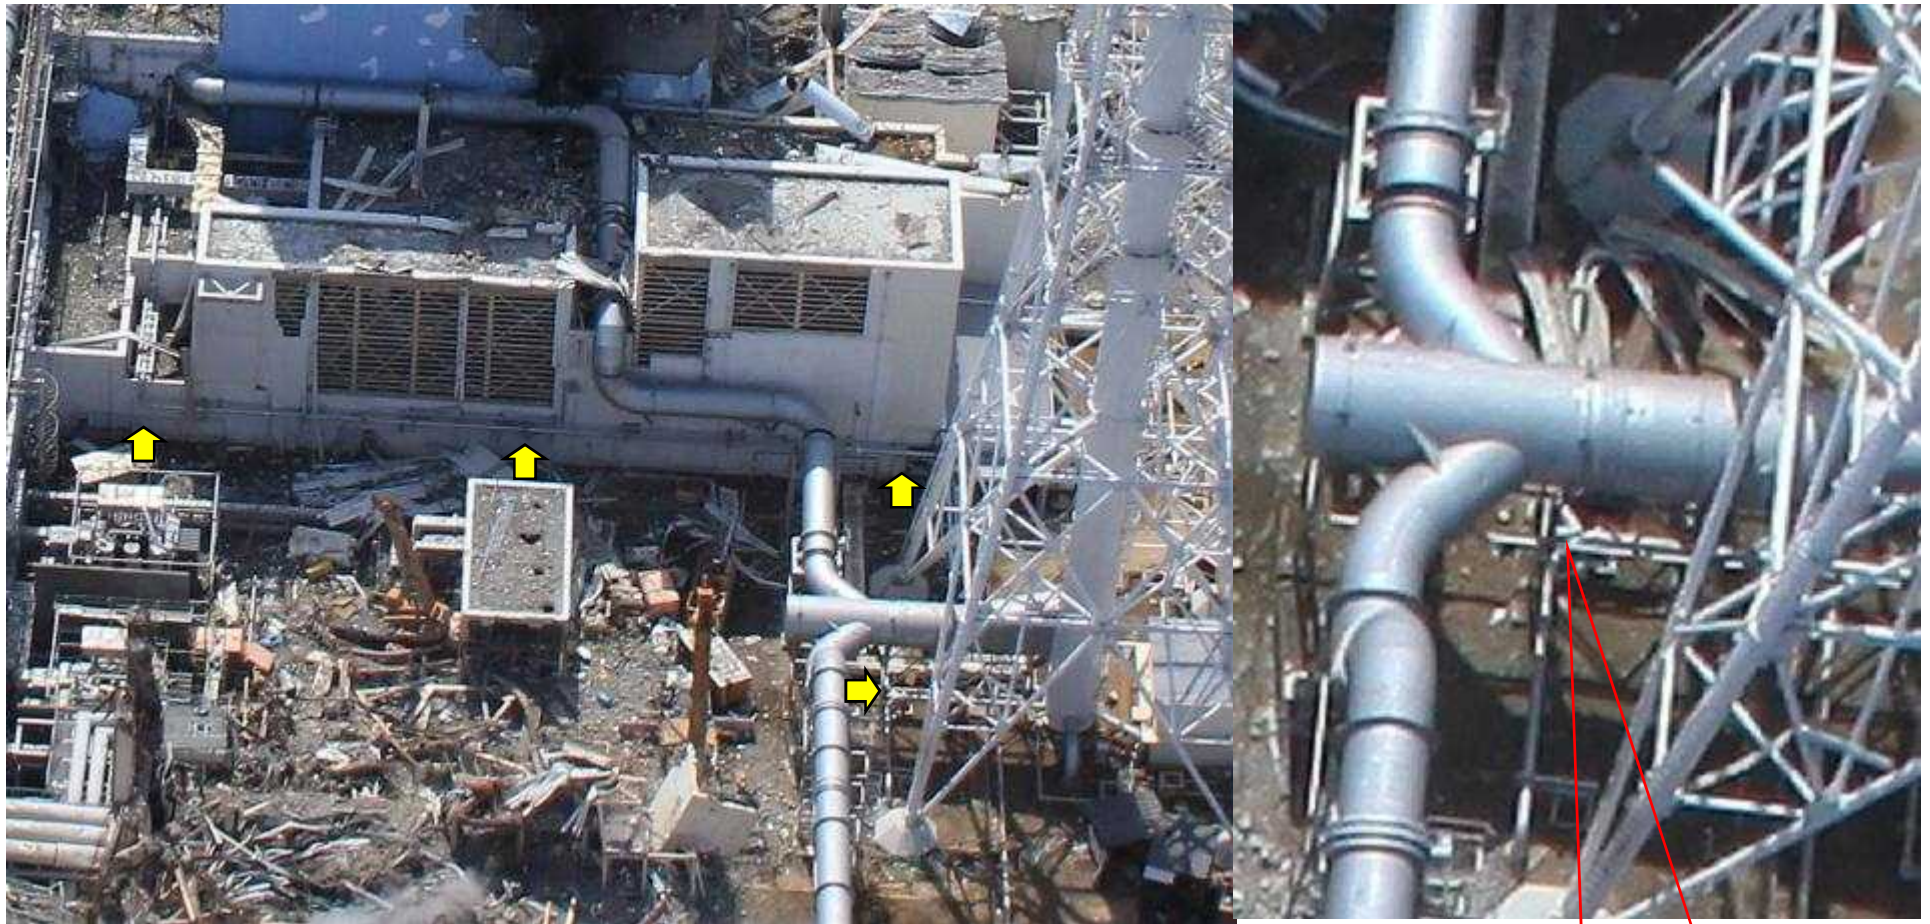
# Stand-by Gas Treatment Systems for Units 3 and 4

***Pipes of stand-by gas treatment systems for Units 3 and 4 are connected.***

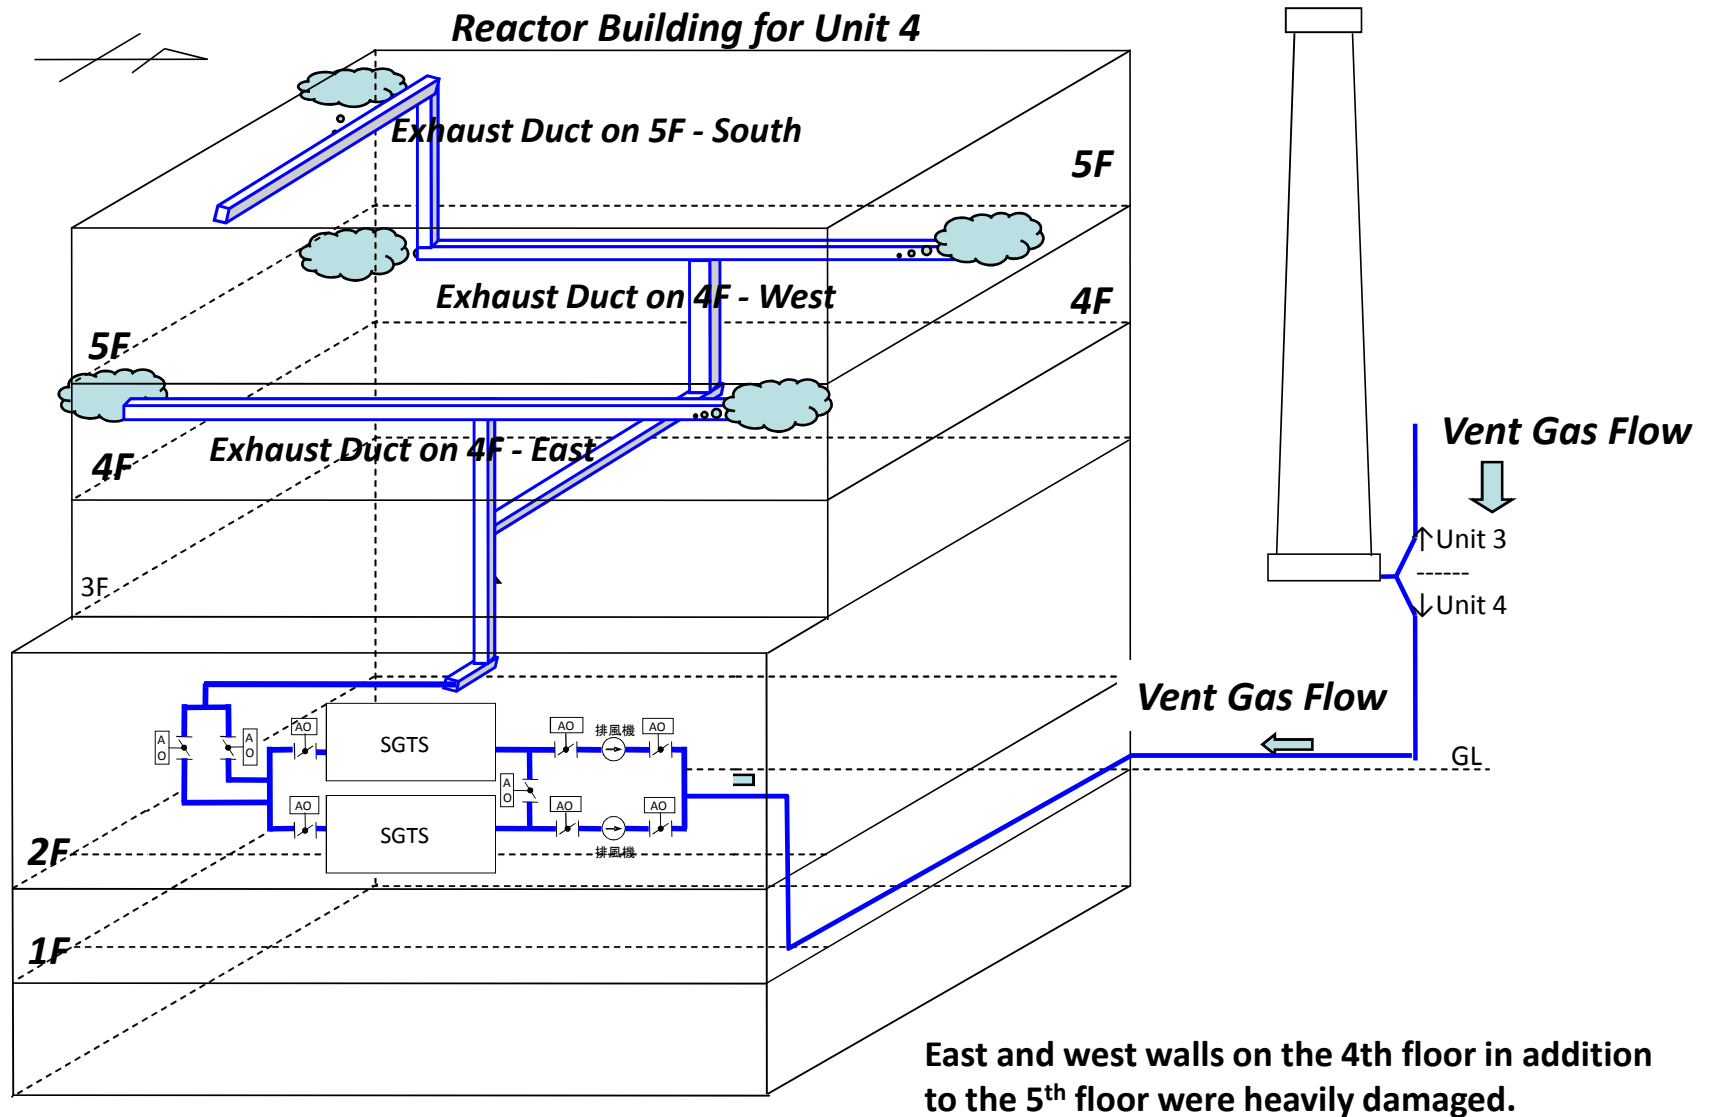
# Possible Mechanism of Hydrogen Explosion in Unit 4

Possible mechanisms ; (1) Zr-H<sub>2</sub>O reaction in the SFP, (2) H<sub>2</sub> from Unit 3,  
(3) Decomposition of H<sub>2</sub>O into H<sub>2</sub> and O<sub>2</sub> under radiation

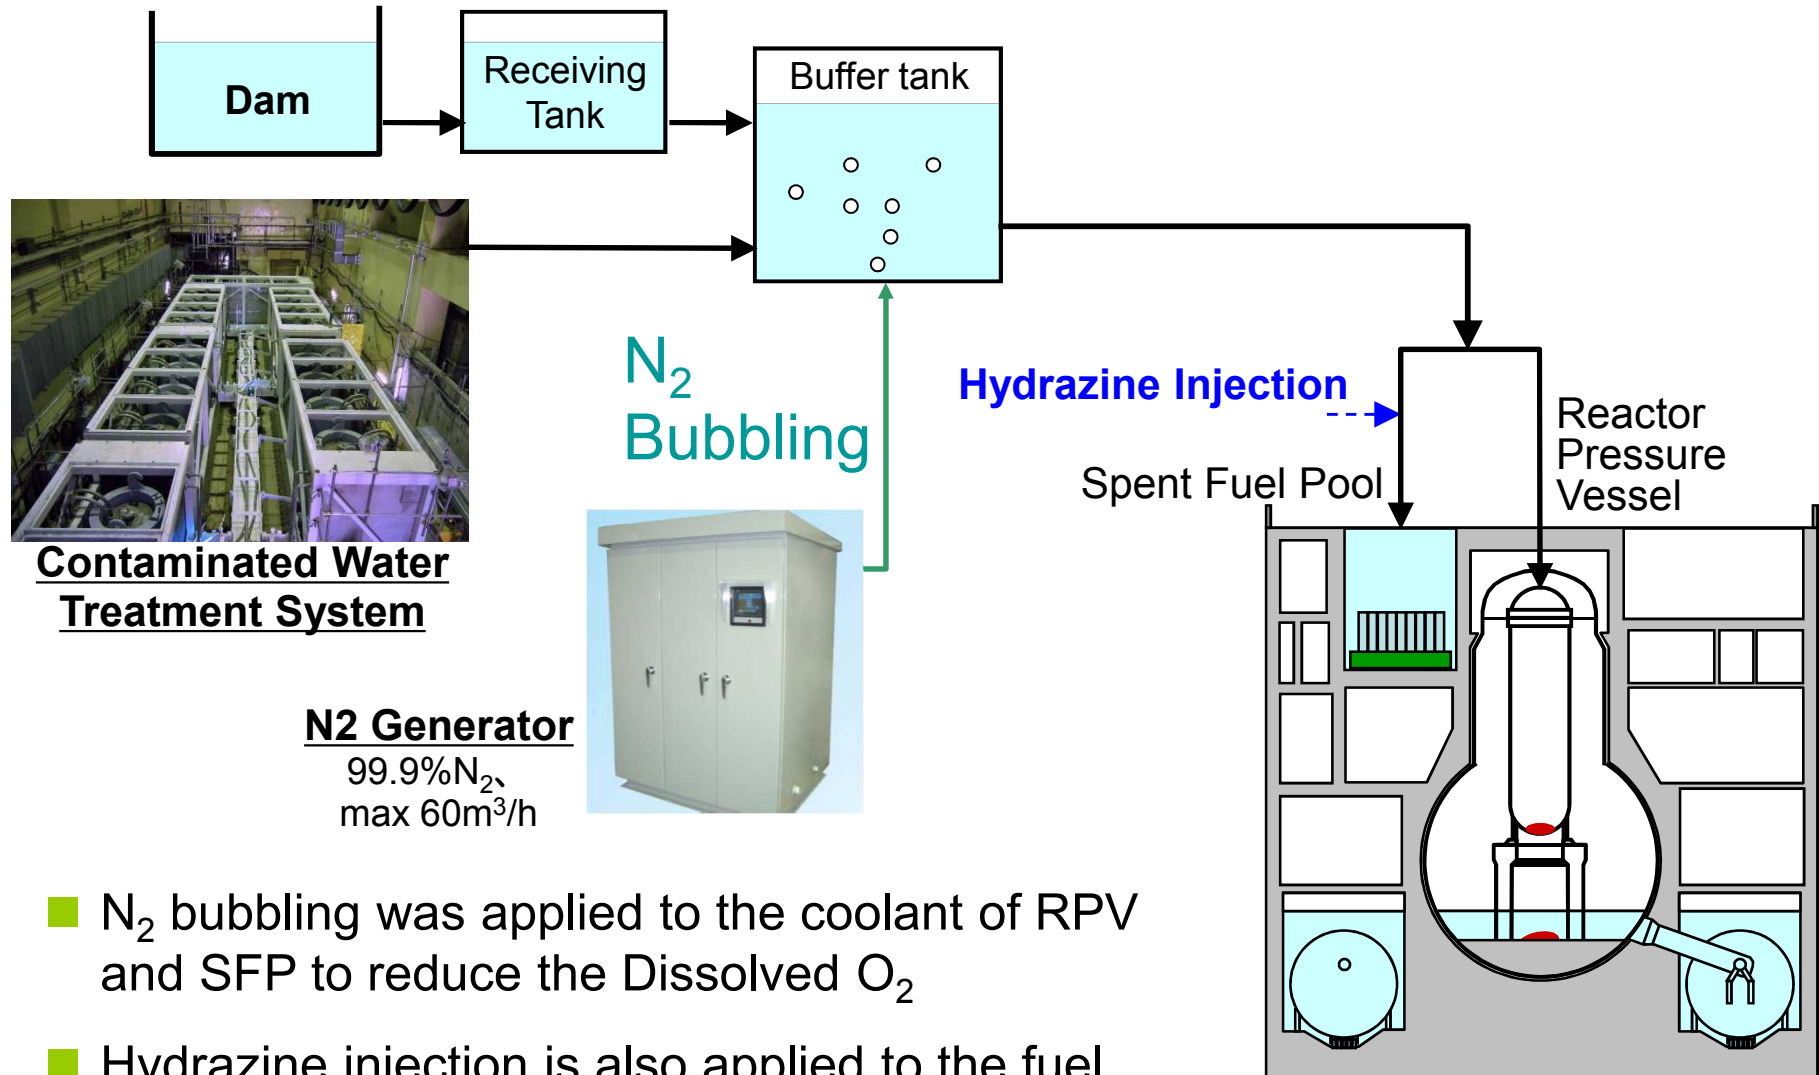
# Reduction of Dissolved Oxygen (Nitrogen Bubbling)

- N<sub>2</sub> bubbling was applied to the coolant of RPV and SFP to reduce the Dissolved O<sub>2</sub>
- Hydrazine injection is also applied to the fuel pool of Units 2~4

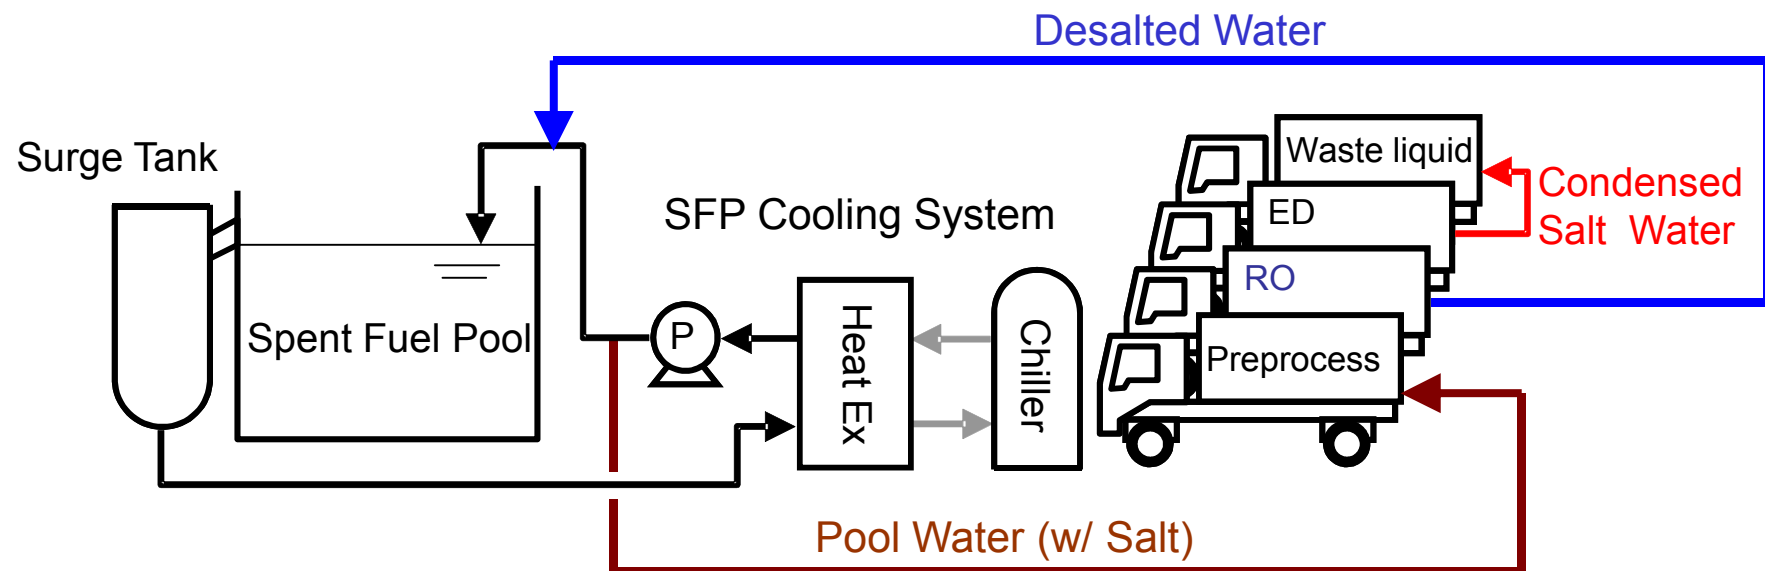
# Desalting from Spent Fuel Pools

To reduce Cl<sup>-</sup> concentration to < 10 ppm in order to prevent localized corrosion of fuel pool liner made of 304 stainless steel

- (1) Pre-processing: Removal of oil and radioactive materials to protect RO
- (2) **Reverse Osmosis membrane (RO)**: Transferring salt to waste liquid
- (3) Electrodialytic Treatment (ED): Condensing waste liquid  
→ Desalted water: 94%, Waste liquid: 6%
